Models Affected: RHFE-201FA, RHFE-263FA / FAII, RHFE-431FA / FAII / FAIII / WTA,
RHFE-556FA / FAIII / FTRA / FTRAIII / WTA

When accomplishing any maintenance or repair that involves removing the burner box fitting plate, it is recommended that the burner box plate, packings, screws, and electrode parts be replaced with the Burner Box Fitting Plate Kit, part number 204000018. Use of this kit will make the service procedure much simpler. Details of the kit and part locations are shown below.

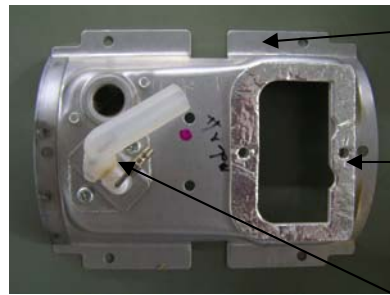
Burner box fitting plate (1)

Manifold Gasket (1)

Electrode (1)
Electrode Packing (1)
Electrode Retainer (1)
Electrode Sleeve (1)

The old packing/gasket must not be re-used. It is necessary to replace this packing/gasket when accessing the burner area to guarantee a seal and prevent the appliance from operating in an unsafe condition. Damage to the appliance may also occur if the old packing/gasket is re-used.

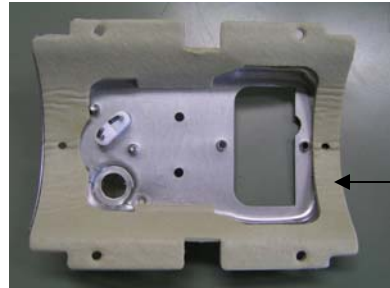
Plate Gasket (1)

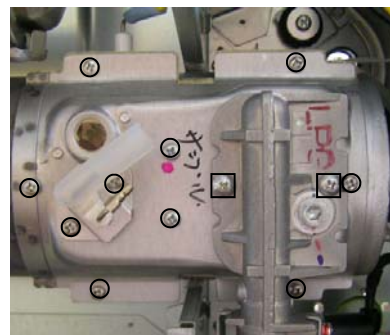
○ Screws, Plate and Electrode Retainer (10)

□ Screws, Manifold (10)
